FAILURE DETECTION AND RECOMMENDED ACTIONS

BEL Composite Iberica S.L., in its commitment to safety, develops this document to publicize the technology and the constructive form of its pressure vessels for Reverse Osmosis, in order to facilitate finding failures during operation, determine their degree of severity, and provide guidance on the most recommended corrective actions.

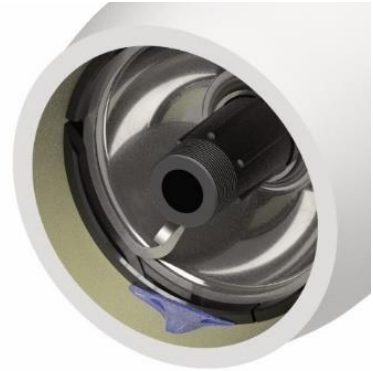
2.1. Endcap leaks

- **Description:** the vessel presents some water leaks through the endcap.
- **Actions to be taken:** replace endcap sealing as soon as possible (no type of leakage is tolerable). If the issue is solved, it should not be considered a serious problem. If it keeps leaking after replacing the sealing, see point 2.3.
- **Severity level:** Low (if leak is detected soon)
- **Expected lifespan:** Not affected

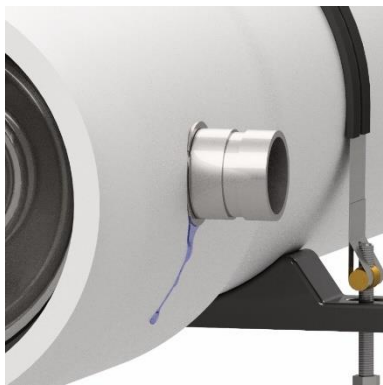
2.2. Side port leaks

- **Description:** the vessel presents leaks through the side port.
- **Actions to be taken:** replace the side port sealing as soon as possible (no type of leakage is tolerable). If the issue is solved, it should not be considered a serious problem. If it keeps leaking after replacing the sealing, see point 2.5 and 2.6.
- **Severity level:** Low (if leak is solved soon)
- **Expected lifespan:** Not affected

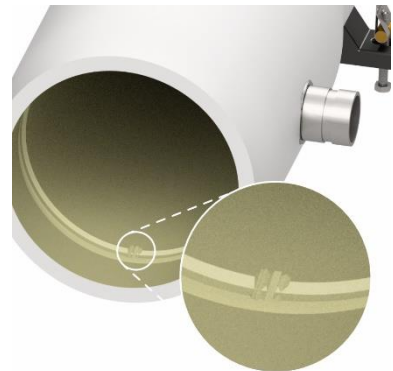
2.3. Damage in the sealing groove

- **Description:** the vessel presents scratches or surface defects in the sealing groove.
- **Actions to be taken:** repair according to manual. For cracks in the sealing groove please see point 2.6
- **Severity level:** Medium
- **Expected lifespan:** Not affected if solved soon and correctly. Do close monitoring and watch out for new symptoms.

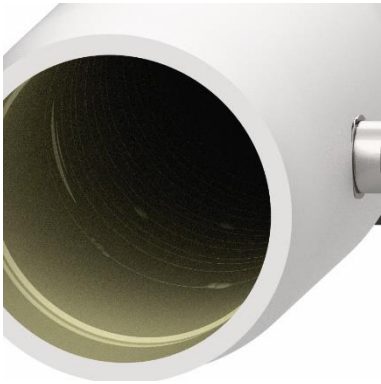
2.4. Damage in internal surface

Description: the vessel presents scratches, white bubbles or other kind of damage in the inner face.

Severity level: Medium/high, depending on the quantity and size.

Expected lifespan: Close monitoring and replacement plan replacement

Actions to be taken: not repairable. Water has penetrated in the inside of the laminate. The extent of the damage cannot be determined

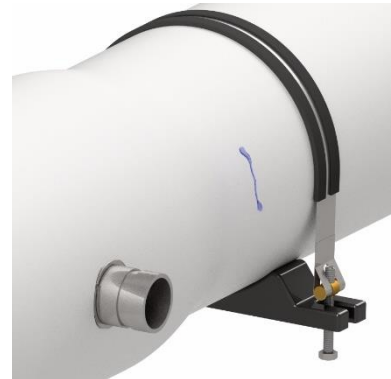
2.5. Body leaks

Description: vessel shows leakages through the body.

Severity level: High

Expected lifespan: Close to catastrophic failure risk.

Actions to be taken: never repair or block these leaks with resin. Water has penetrated in the inside of the laminate. The extent of the damage cannot be determined. Replace the vessel immediately

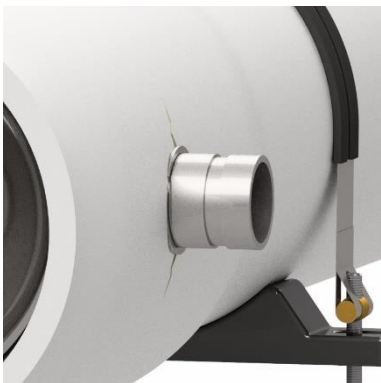
2.6. Cracks

Description: Cracks are found, starting from the side port drill in the bell, or in the inner groove of the vessel.

Severity level: High

Expected lifespan: Immediate catastrophic failure risk.

Actions to be taken: Replace the vessel immediately
