FAILURE DETECTION AND RECOMMENDED ACTIONS

BEL Composite Iberica S.L., in its commitment to safety, develops this document to publicize the technology and the constructive form of its pressure vessels for Reverse Osmosis, in order to facilitate finding failures during operation, determine their degree of severity, and provide guidance on the most recommended corrective actions.

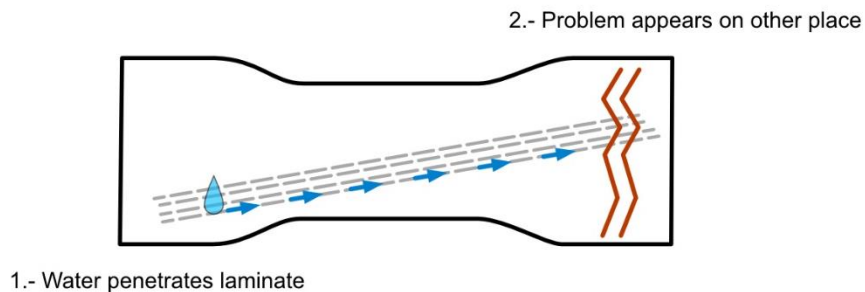
Because the fiber is wound throughout the entire vessel, if water penetrates the laminate through a pore or crack inside the vessel, symptoms could appear at the other end of the vessel.

- Water penetration problem behavior inside the laminate -
